## EPDM COOLANT HOSE WITH HD ALUMINUM FITTING

11537598234PRM | ÜRO-014177 | 2012-2018 BMW

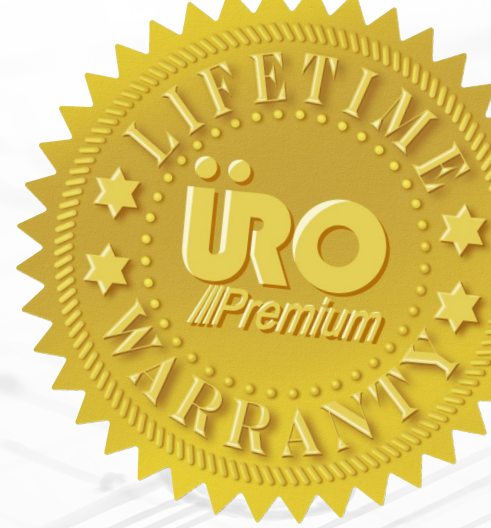
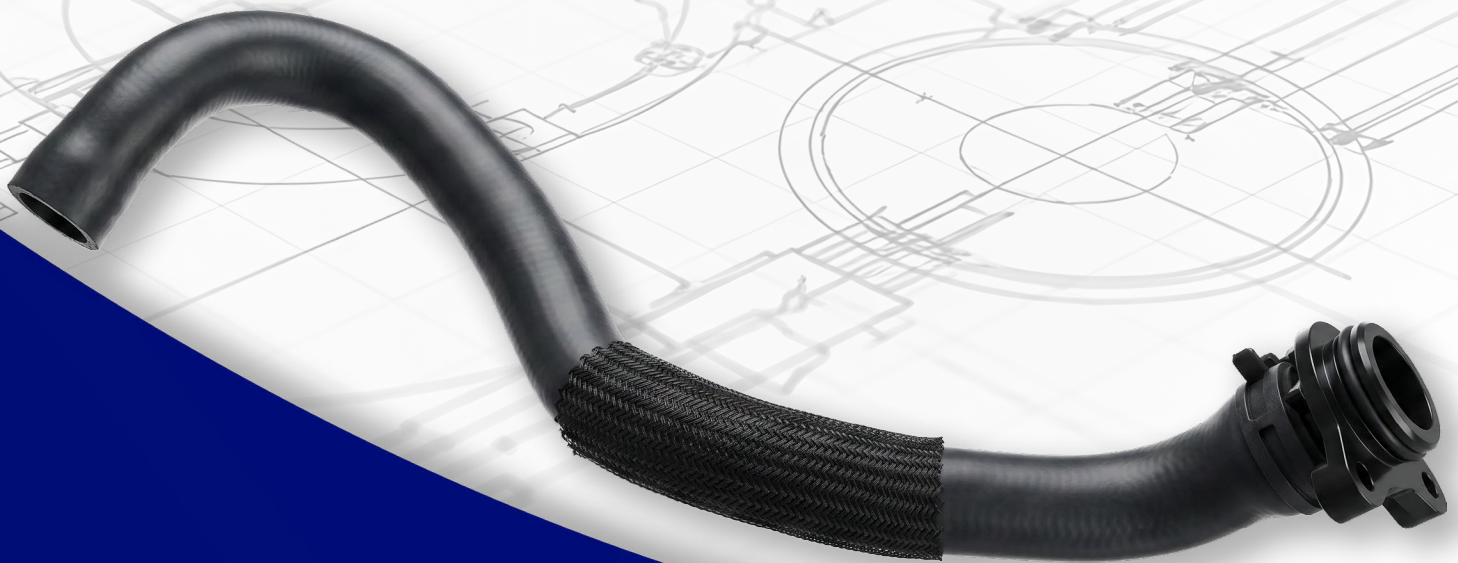
Plastic fittings in coolant hose assemblies are prone to catastrophic failure after thermal cycles and exposure to oil, grease, or transmission fluid. The embrittled plastic eventually ruptures, resulting in a major leak and dangerous overheating.

ÜRO has developed Premium hoses equipped with aluminum fittings, which are impervious to engine heat, motor oil and ATF. Upgraded EPDM synthetic rubber and sturdy all-metal fitting fixes the problem right the first time, for a truly robust repair.
