# PRODUCT UPDATE

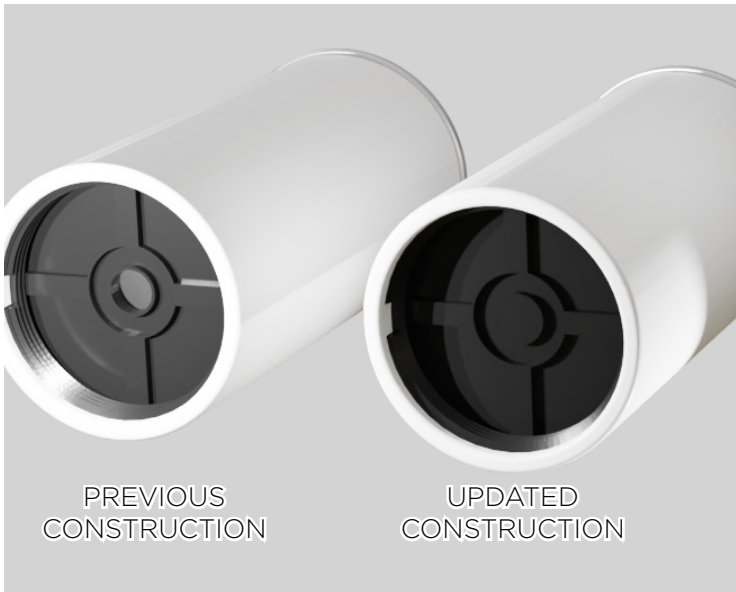
The WIX 33783 fuel filter has undergone a design change. The center hole that was part of the former construction **is no longer required** for the new construction. Filtered water content coalesces on the outside of the media and drains down the side of the filter into the bowl to be drained as necessary.

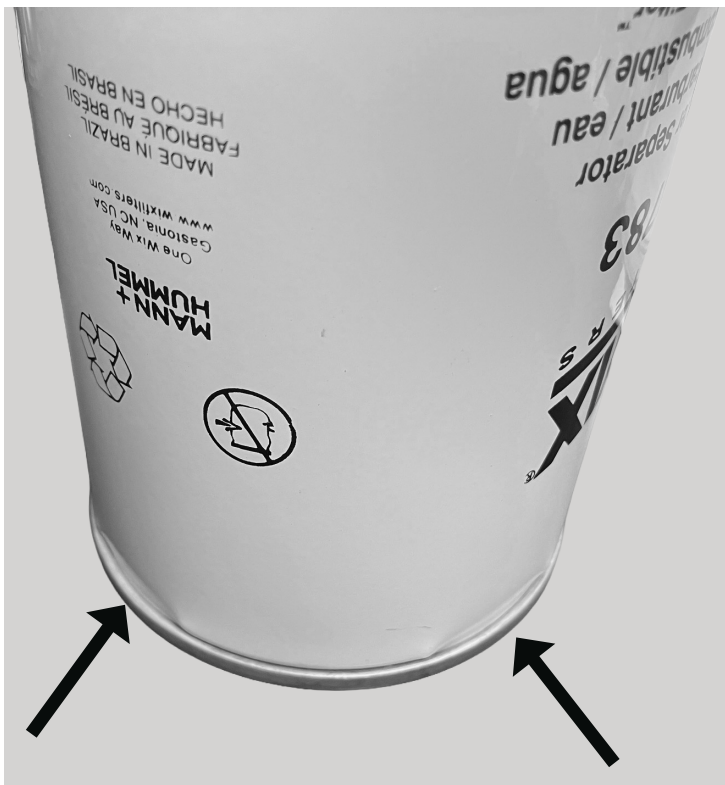
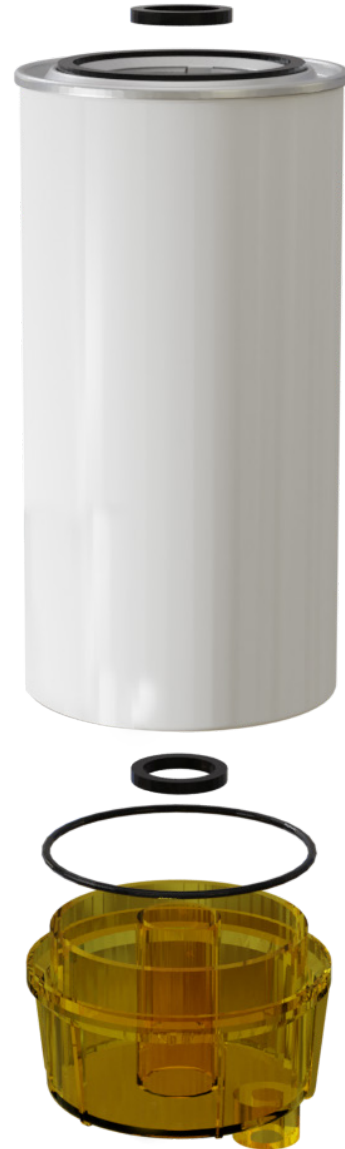
The indexed indentations visible in the seamed area of the can are the result of the use of an alternate baseplate construction. The shape of this baseplate prevents the can from rotating independently of the threaded plate once the two are seamed. The process used to make this geometry also reduces overall metal waste which supports environmental waste reduction efforts. When seamed, the filter can conforms to the shape of the baseplate resulting in the indentations identified in the illustration. The indentations **should not be confused with dents or damaged seams.**
